INTERNATIONAL JOURNAL OF TRENDS IN EMERGING RESEARCH AND DEVELOPMENT

Foundation repair for Earthfill dams to mitigate piping and boiling phenomenon

Keywords: Embankment dams, collapse risk, seepage, foundation repair safety factors

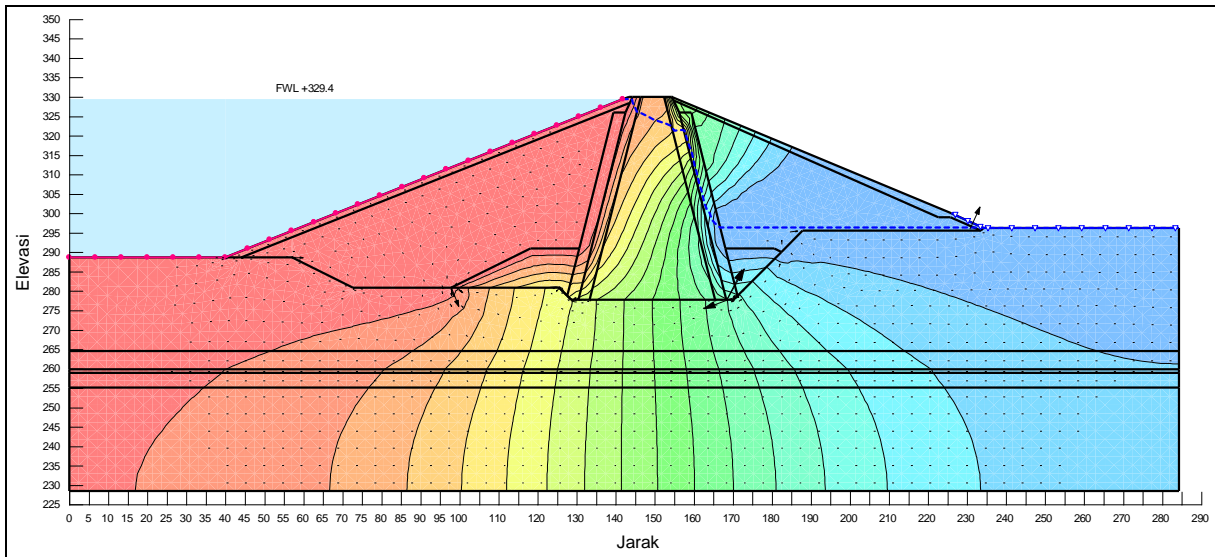
Fig 3: SEEP/W Results for STA +575 under Unrepaired Foundation Conditions at Flood Water Level (FWL)

The seepage analysis results, conducted using the Geostudio Sub-program SEEP/W, were based on the Normal Water Level (NWL) conditions obtained from the Bagong Dam planning data, which is +325, and the Flood Water Level (FWL) determined through hydrological analysis at +329.4. The analysis was performed at various STA, as illustrated in Figure 3 for STA +575, Figure 4 for STA +425, and Figure 5 for STA +225.

The seepage analysis using the SEEP/W sub-program yielded hydraulic gradient values, which were then utilized to calculate the piping safety factor using Equation 4. The calculated results are presented in Table 2, showcasing the safety factor values for piping under both Normal Water Level (NWL) and Flood Water Level (FWL) conditions across several analyzed STA.

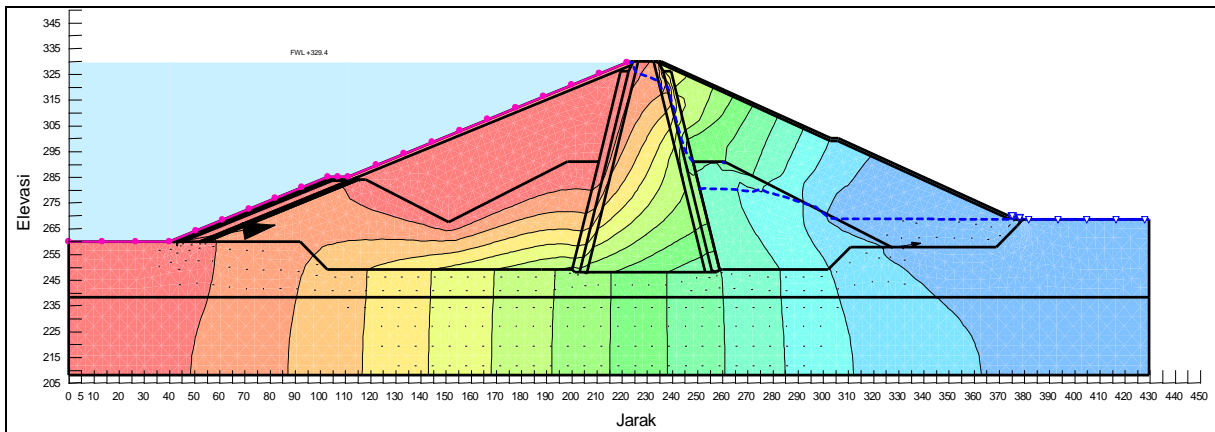
Fig 4: SEEP/W Results for STA +425 under Unrepaired Foundation Conditions at Flood Water Level (FWL)

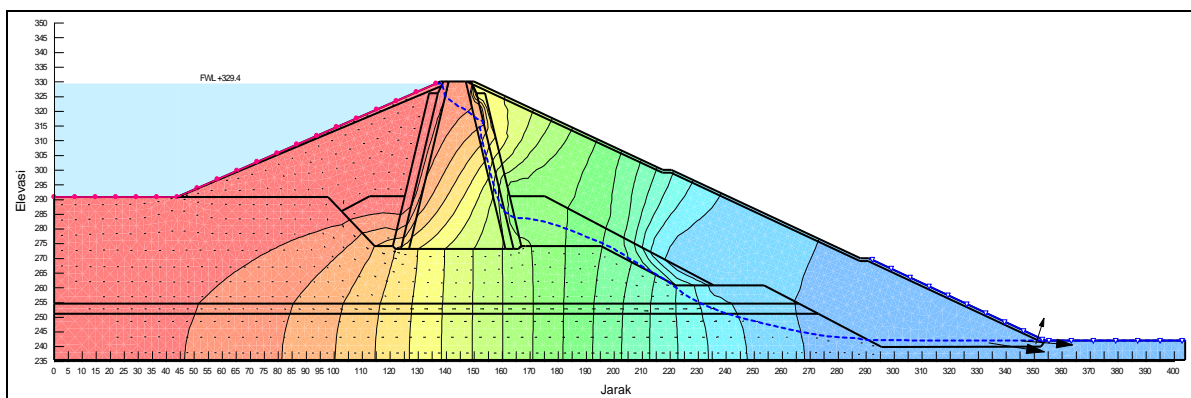
Fig 5: SEEP/W Results for STA +225 under Unrepaired Foundation Conditions at Flood Water Level (FWL)
